**Flood Control Project Maintenance
Levee Inspections
LMA District Cover Sheet
Spring 2010 Levee Inspection Results**

Reclamation District No. 1600 Mull

Levee Inspection Report By Mile - Spring 2010

Waterway						Bank	Unit Miles	Inspection Start/End	Inspector	
Unit No. 01 Sacramento River						Right	10.51	05/07/2010 05/07/2010	John Williamson	
LMR No	Levee Mile		Category	Item	Location	Rating	Action/Comment	GPS Latitude/Longitude		Issue No. Photo
	Start	End						Start	End	
1	0.01	0.09	Earthen Levee	Encroachments	WS CO	Fences Inspector Comments: chain link completely blocks access to waters edge		38.675242 ° -121.630492 °	38.676356 ° -121.631157 °	3 Y
2	0.06	0.06	Earthen Levee	Encroachments	WS PO	Buildings Inspector Comments: this is the home and pumping plant for RD 2035		38.675998 ° -121.630732 °	38.675998 ° -121.630732 °	1 Y
3	0.10	10.51	Earthen Levee	Vegetation	LS M	Control annual grass and weeds on the levee slopes and easements.		38.676480 ° -121.631220 °	38.765486 ° -121.634938 °	4
4	0.10	10.51	Earthen Levee	Vegetation	WS M	Control annual grass and weeds on the levee slopes and easements.		38.676479 ° -121.631219 °	38.765488 ° -121.634941 °	5

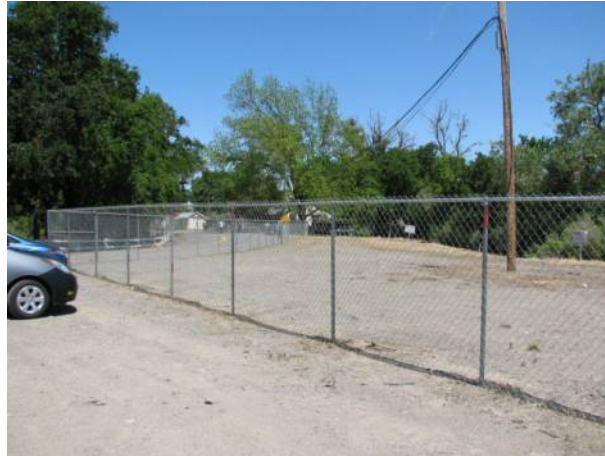
Levee Mile Report Line	1
Start Levee Mile	0.01
End Levee Mile	0.09
Location	Water Side
Category	Earthen Levee
Item	Encroachments

Chain link fence no permit

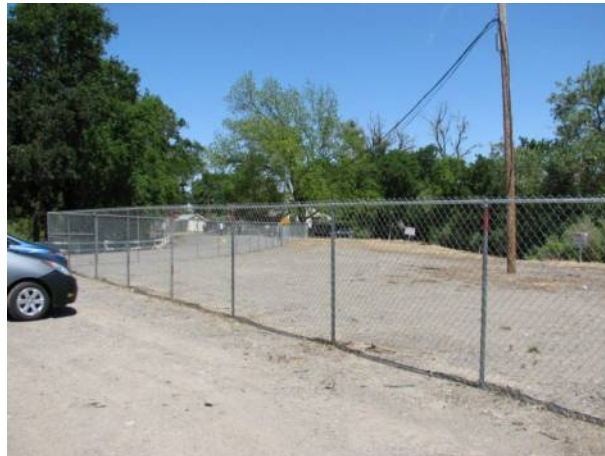
Levee Mile Report Line	2
Start Levee Mile	0.06
End Levee Mile	0.06
Location	Water Side
Category	Earthen Levee
Item	Encroachments

Building in back ground next to pumping plant

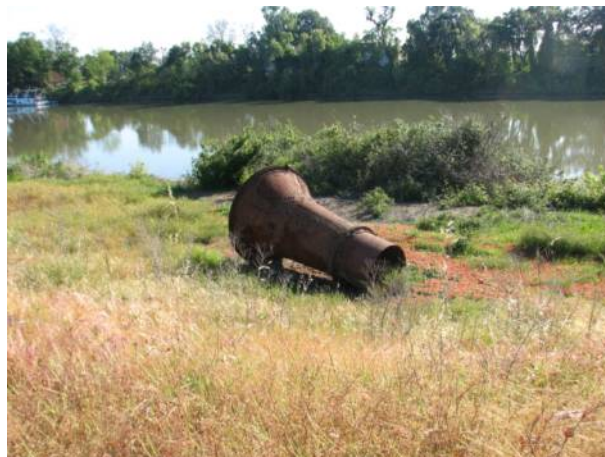
Levee Mile Report Line	6
Start Levee Mile	0.35
End Levee Mile	0.35
Location	Water Side
Category	Earthen Levee
Item	Encroachments

funnel on waterside

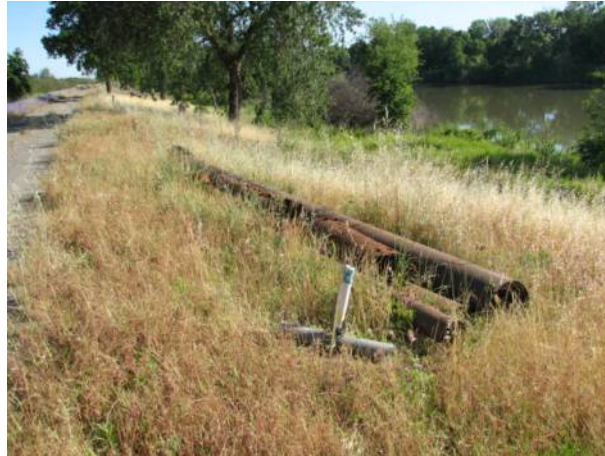
Levee Mile Report Line	7
Start Levee Mile	0.54
End Levee Mile	0.54
Location	Water Side
Category	Earthen Levee
Item	Encroachments

pipe left from repair

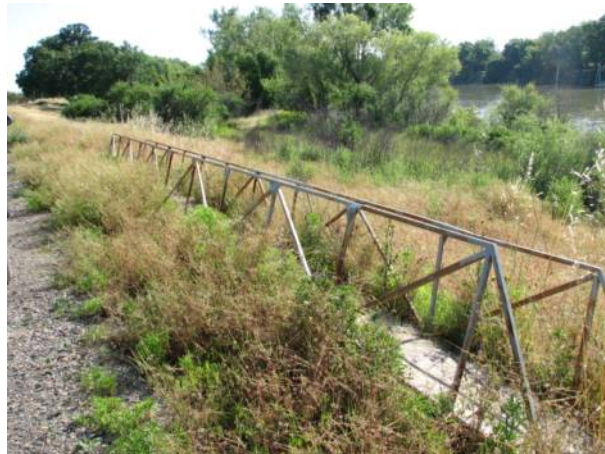
Levee Mile Report Line	9
Start Levee Mile	1.71
End Levee Mile	1.71
Location	Water Side
Category	Earthen Levee
Item	Encroachments

ramp for dock not being used

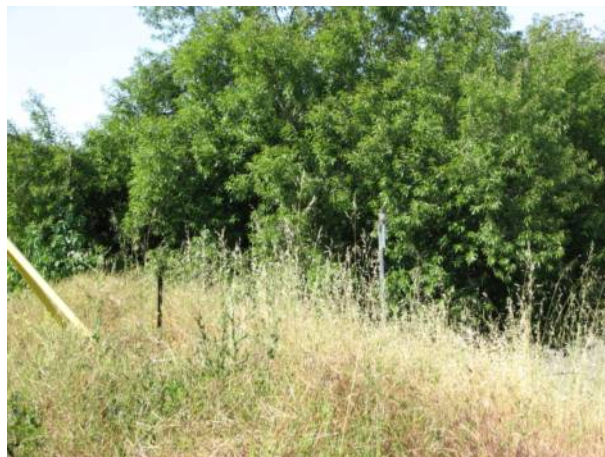
Levee Mile Report Line	14
Start Levee Mile	5.88
End Levee Mile	5.88
Location	Land Side
Category	Earthen Levee
Item	Trim / Thin Trees

tree blocking levee slope

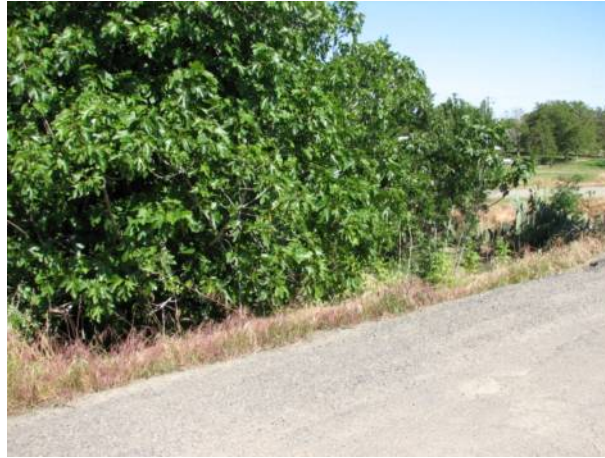
Levee Mile Report Line	15
Start Levee Mile	6.33
End Levee Mile	6.33
Location	Land Side
Category	Earthen Levee
Item	Trim / Thin Trees

fig tree on levee slope, cactus in back ground

LMR No	Levee Mile		Category	Item	Location *	Rating **	Action/Comment	GPS Latitude/Longitude		Issue No. Photo
	Start	End						Start	End	
15	6.33	6.33	Earthen Levee	Trim / Thin Trees	LS	M	Trim trees to at least five feet above ground level. Inspector Comments: fig tree needs to be trimmed or removed cactus at levee toe	38.755242 ° -121.594620 °	38.755242 ° -121.594620 °	15 Y
16	6.62	6.68	Earthen Levee	Trim / Thin Trees	LS	M	Thin trees to allow visibility of the ground and room to flood fight.	38.759531 ° -121.594108 °	38.760358 ° -121.594164 °	11
17	7.00	7.00	Earthen Levee	Erosion / Bank Caving	WS	M	Note and monitor erosion site.	38.764940 ° -121.595348 °	38.764940 ° -121.595348 °	14
18	7.13	7.13	Earthen Levee	Erosion / Bank Caving	WS	M	Note and monitor erosion site.	38.766505 ° -121.596214 °	38.766505 ° -121.596214 °	20
19	7.27	7.27	Earthen Levee	Erosion / Bank Caving	WS	M	Note and monitor erosion site.	38.768409 ° -121.597213 °	38.768409 ° -121.597213 °	21

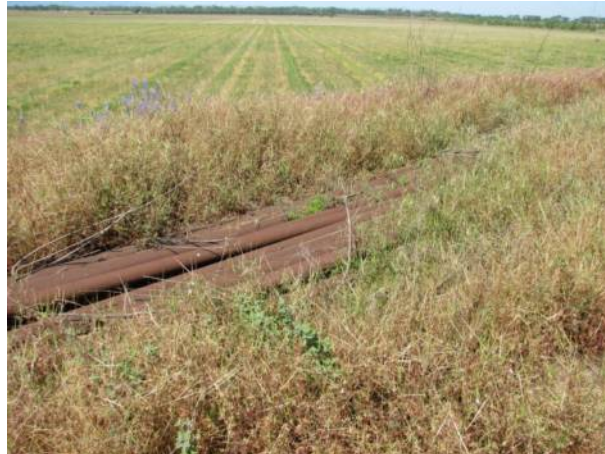
Levee Mile Report Line	20
Start Levee Mile	7.85
End Levee Mile	7.85
Location	Land Side
Category	Earthen Levee
Item	Encroachments

drilling pipe on levee crown landside

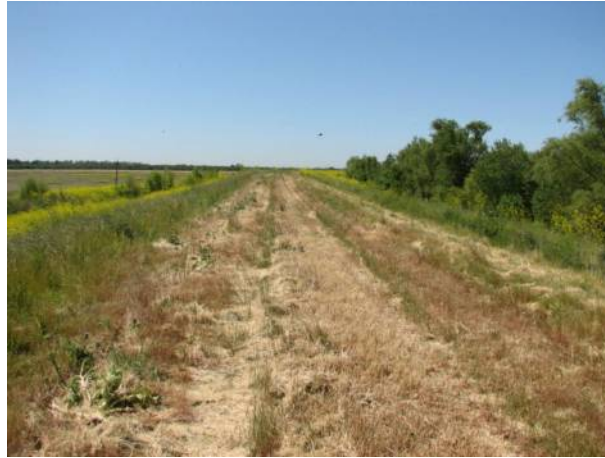
Levee Mile Report Line	5
Start Levee Mile	0.81
End Levee Mile	4.18
Location	Crown
Category	Earthen Levee
Item	Crown Surface / Depressions / Rutting
weeds on crown cannot see gravel roadway	
johngw_s_20100510_151.jpg
